LESSONS FROM NOTABLE EVENTS

THE BALDWIN HILLS RESERVOIR FAILURE

THOMAS M. LEPS AND ROBERT B. JANSEN

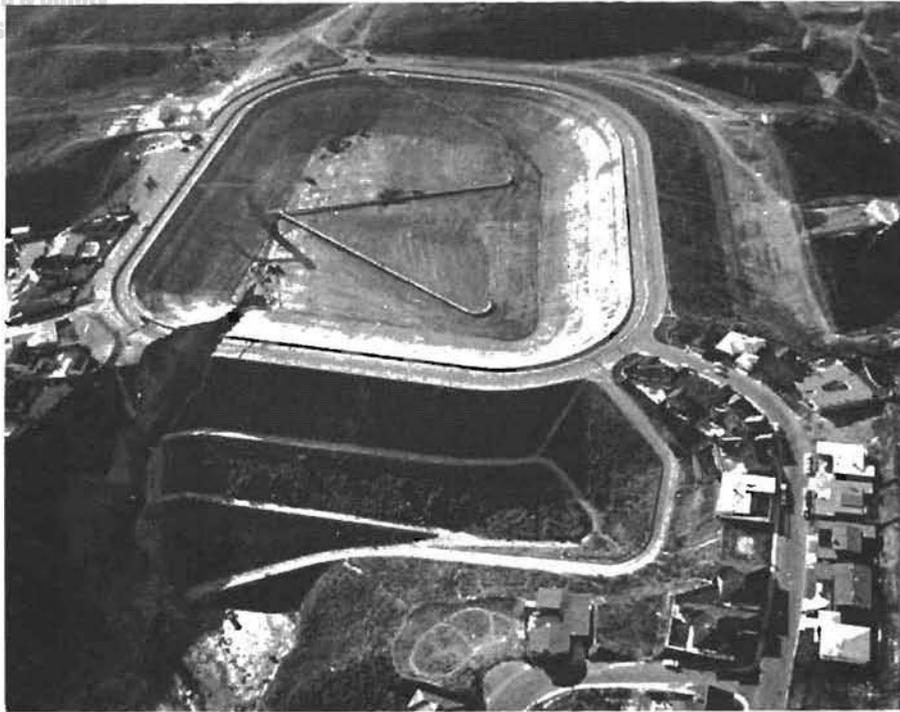
At approximately 1:00 P.M., muddy leakage was discovered downstream from the east abutment of the dam, which formed the north side of the reservoir. At 2:20 P.M., lowering of the reservoir water level revealed a 3-ft-wide break in the reservoir's inner lining. A futile attempt was made to plug the hole with sandbags. Water broke violently through the downstream face of the dam. By 5:00 P.M., the reservoir had emptied, revealing a crack in the lining

extending across the reservoir bottom in line with the breach in the dam (Fig. 2-1).

Fig. 2-1. Baldwin Hills Reservoir after failure.

After the failure, about 2 in. (5 cm) of fine silt and clay covered the reservoir floor.¹ There was a continuous crack approximately parallel to and near the toe of the east slope. Vertical displacement averaged about 2 in. (5 cm), but was as much as 7 in. (18 cm), with the west side of the crack lower than the east side. The crack extended up the south

slope of the reservoir but with very little offset. Several sinkholes could be seen in the reservoir bottom along the continuous crack.

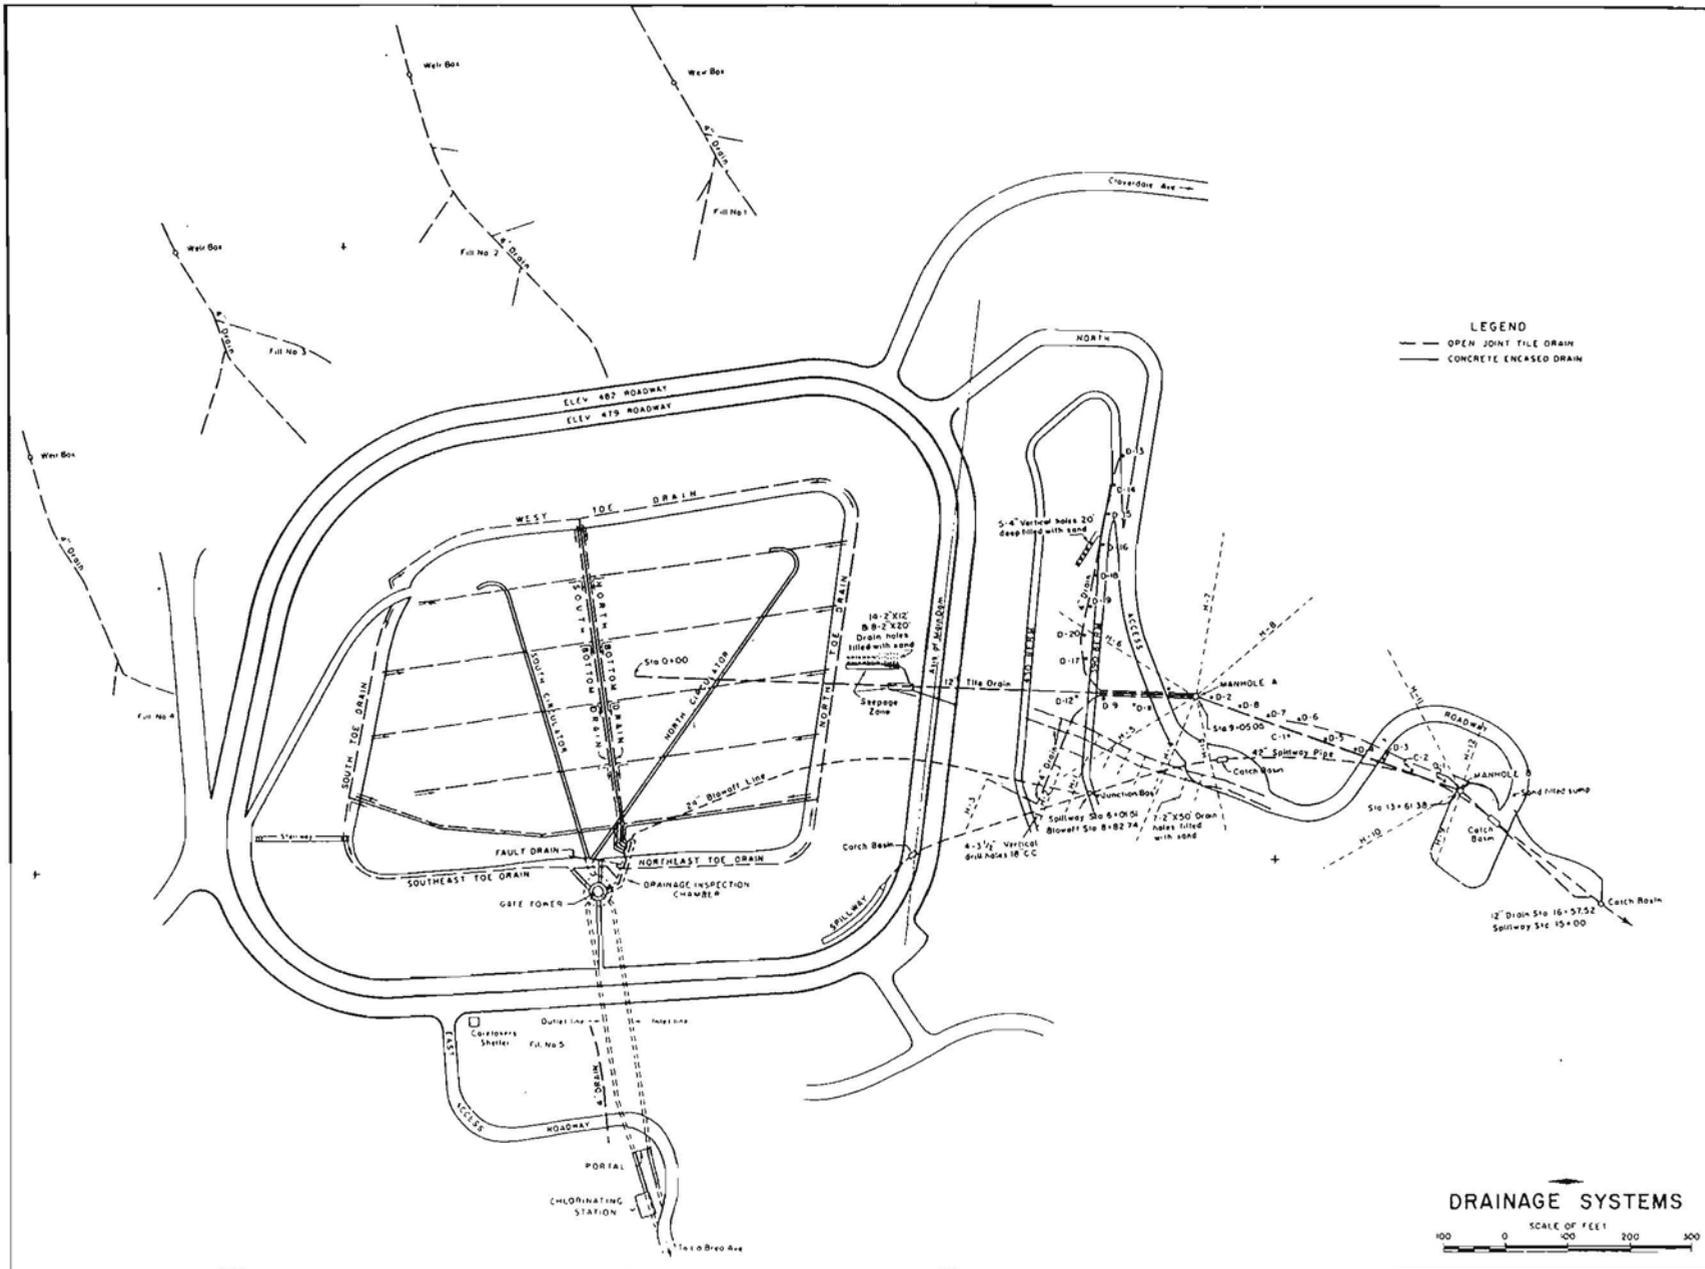
Below the earth lining lay a 4-in. (102-mm) lightly cemented pea-gravel drain blanket, with a system of 4-in. clay tile pipes placed beneath it to convey the leakage to a drainage inspection chamber. The pea-gravel blanket was capped with a $\frac{1}{4}$ -in. porous sand gunite layer to prevent infiltration by soil particles. The lowest member of the lining was an asphaltic membrane about $\frac{1}{4}$ in. thick, sprayed on either the natural formation or compacted fill. Cotton fabric with an open weave served as reinforcement of the membrane where needed, mostly on the slopes and in the ditches for drain tile. The designers realized that the integrity of the reservoir would depend upon the impermeability of the asphaltic underseal.

Two separate underdrain systems were provided, one to drain the foundation under the earth embankments and the other to collect seepage passing through the earth lining and convey it through a central observation and measurement chamber to an outfall pipe.

In the bottom of the ravine under the main embankment was an open-jointed 12-in. (305-mm) clay tile foundation drain, its upper half covered with lightly cemented pea gravel to permit water entry. This drain passed through successive manholes where seepage flow was observed.

Fig. 2-2. Drainage systems, Baldwin Hills Reservoir.

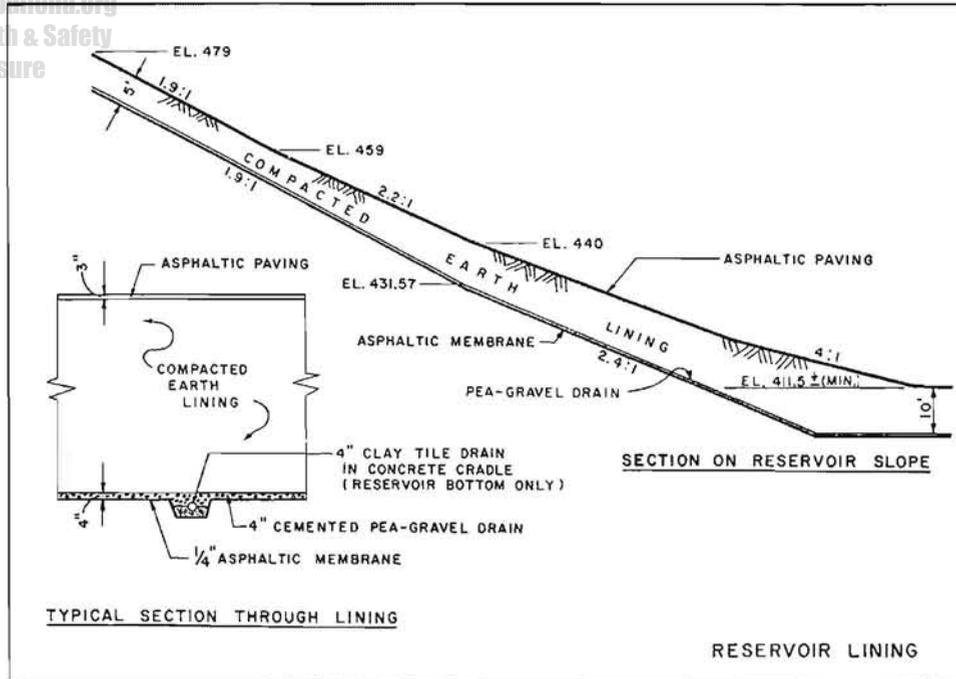
Fig. 2-3. Baldwin Hills Reservoir lining.

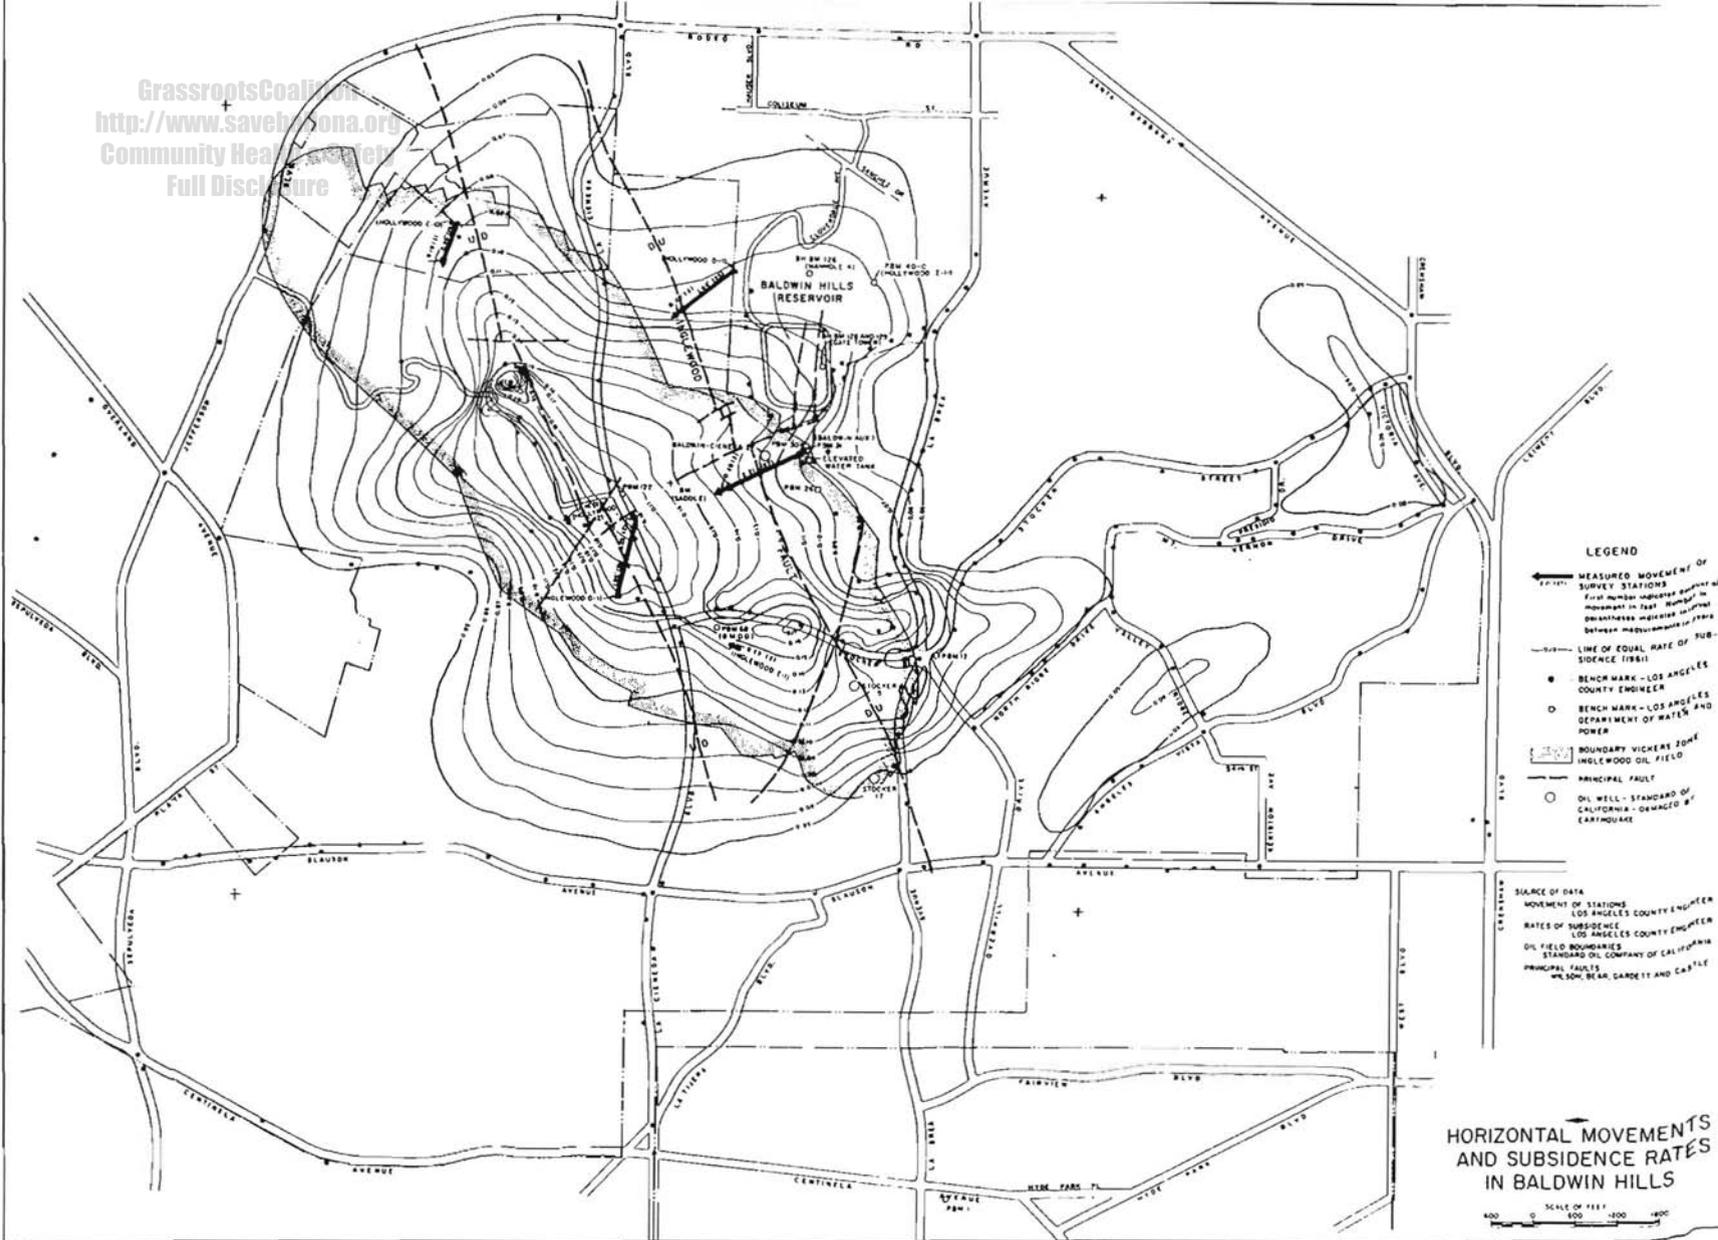
In 1917, the Department of Water and Power established benchmarks at the site of Centinela Reservoir, a proposed storage facility about 3000 ft (900 meters) southwest of the Baldwin Hills damsite. In 1943 levels again were run to some of these points, and the changes since 1917 determined. This and subsequent surveys indicated a general regimen of subsidence in the area (Figs. 2-4 and 2-5). In his extensive investigations, Leps² estimated the year of initial subsidence as about 1924.

The point of maximum cumulative subsidence in 1963 was about 3000 ft (900 meters) northwest of the intersection of La Cienega Blvd. and Stocker Street, over the most productive part of the Inglewood Oil Field. The total area of subsidence resembles an elliptical bowl with its center about 0.5 mile (0.8 km) west of the reservoir and its eastern periphery extending beyond La Brea Avenue. Subsidence at the reservoir site aggregated about 3 ft (0.9 meter) within the 1917-63 period. Its southwest corner had dropped more than the northeast corner. Between 1947 and 1962 the elevation difference between these reservoir corners increased by about 0.5 foot (15 cm).

Triangulation surveys in 1934, 1961, and 1963 showed stations in the Baldwin Hills to be moving laterally in the general direction of the subsidence depression. There was a progressive 0.4-ft (12-cm) elongation of the northeast-southwest diagonal of the reservoir between 1950 and 1963.

Fig. 2-4 Horizontal movements and subsidence rates in Baldwin Hills

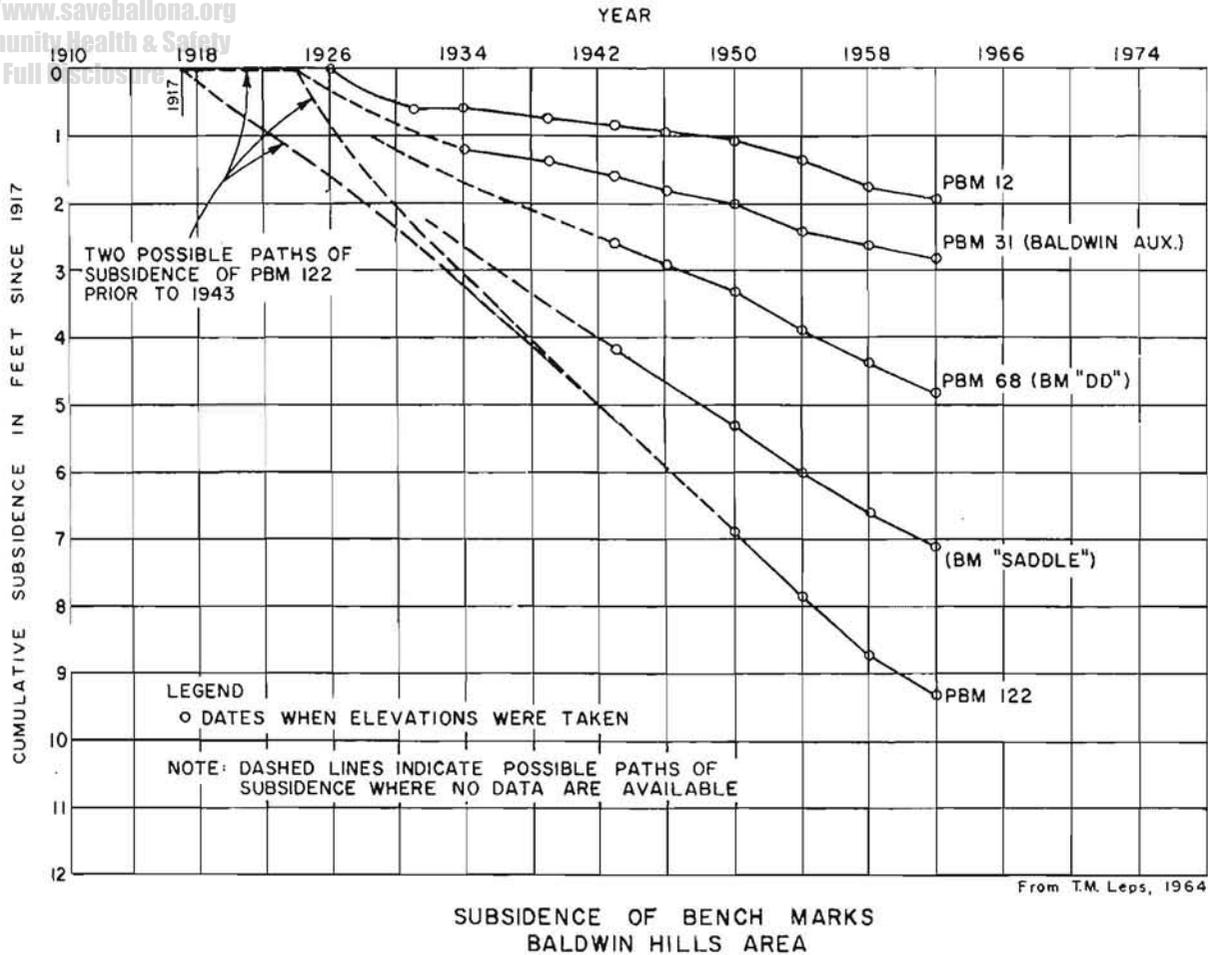
Fig. 2-5. Subsidence of benchmarks, Baldwin Hills area.
